### TEST REPORT No. 8101.3

Requested by: Nolan.UDA Pty. Ltd.  
3 Bradford Street  
Alexandria  
NSW 2015  
on (date): 4 May 2018  
Manufacturer: Imported  
Product Desc.: Images, PP carpet with Latex coating at back.

#### SUMMARY OF SLIP RESISTANCE TESTS PERFORMED:

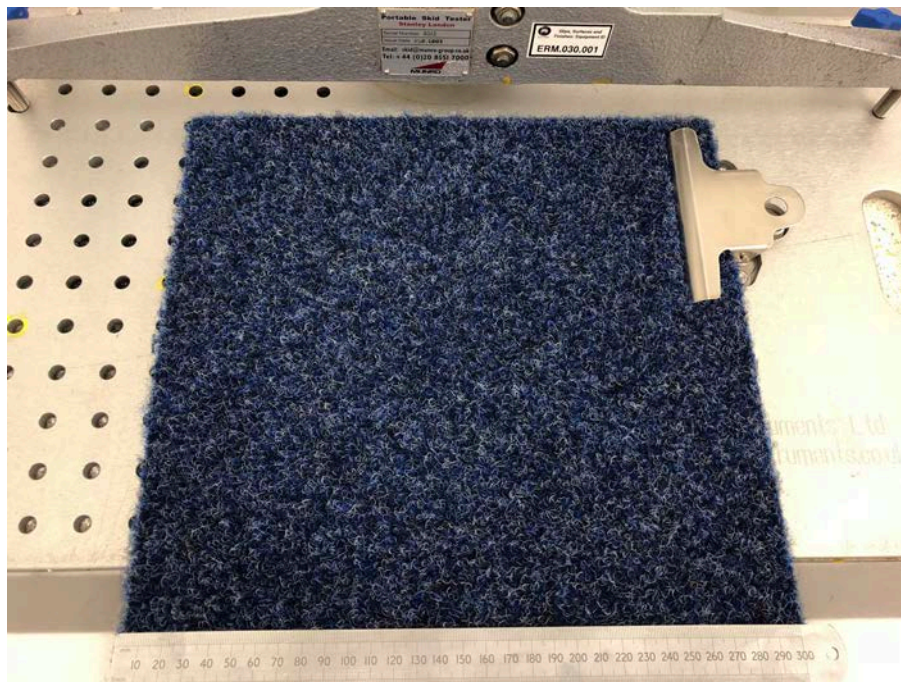
Top view

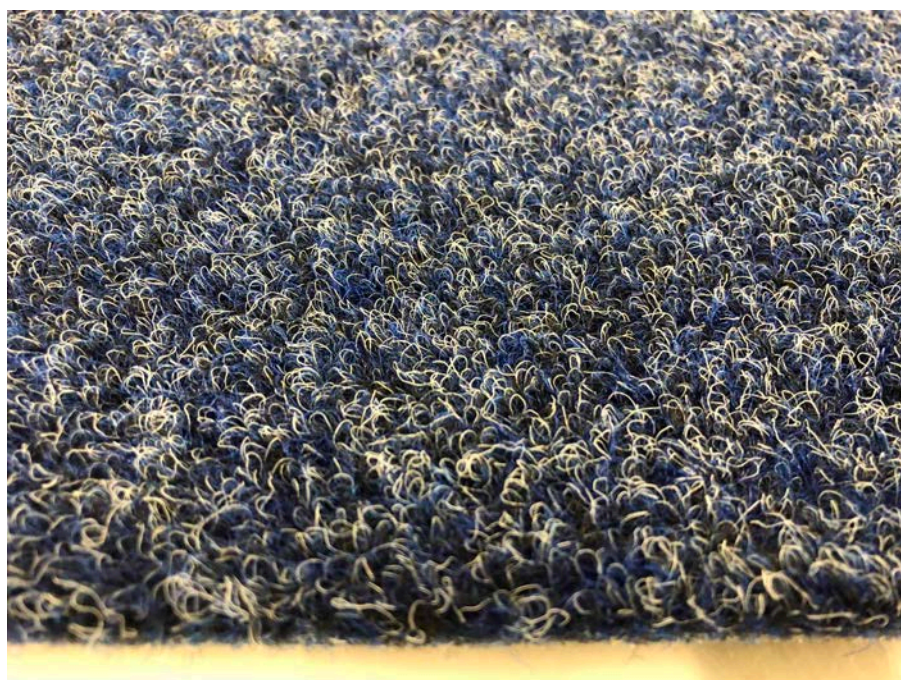
Close up
